**Flood Control Project Maintenance
Levee Inspections**

Maintenance Issue Types Only, Levee Inspection Report By Mile - Fall 2016

Reclamation District No. 0551 Pearson

Waterway	Bank	Unit Miles	Inspection Start/End	Inspector
Unit No. 01 Sacramento River	Left	6.78	10/18/2016 10/18/2016	Herman Phillips

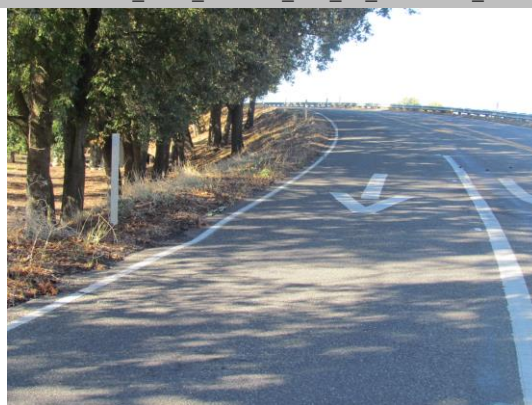
Photo 1 of 1 : FA_2016_RD0551_175_18_20161101_00038.jpg

LM Start	0.03	Rating **	A	Issue No.	18
LM End	6.78	Issue Type +	Ma	Location *	LS
Category	Earthen Levee		GPS Latitude/Longitude		
			Start	End	
Item	Vegetation		38.336123°	38.258886°	
			-121.565020°	-121.517901°	
DWR ID	DWR_RD0551_01_f_2016_18				
Comment Code					
V1 : Control annual grass and weeds on the levee slopes and easements.					
Inspector Comment					
The goats has gone throughout the District both landside and waterside slopes has been maintained from levee 0.03- to 6.78. Good job on vegetation removal.

RD 551 Looking downstream from levee mile 0.03 landside slope.
